# Applying and validating the PTVA-3 Model at the Aeolian Islands, Italy: assessment of the vulnerability of buildings to tsunamis

The aim of this study is to assess the vulnerability of buildings to damage from tsunamis located within the same area inundated by the 2002 event. The assessment is carried out by using the PTVA-3 Model (Papathoma Tsunami Vulnerability Assessment, version 3). The PTVA-3 Model calculates a Relative Vulnerability Index (RVI) for every building, based on a set of selected physical and structural attributes. Run-up values within the area inundated by the 2002 tsunamis were measured and mapped by the Istituto Italiano di Geofisica e Vulcanologia (INGV) and the University of Bologna during field surveys in January 2003. Results of the assessment show that if the same tsunami were to occur today, 54 buildings would be affected in Stromboli, and 5 in Panarea. The overall vulnerability level obtained in this analysis for Stromboli and Panarea are “average”/“low” and “very low”, respectively. Nonetheless, 14 buildings in Strom-

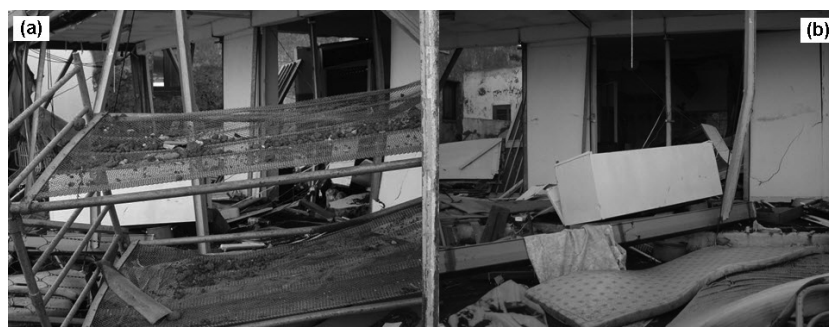
**Fig. 12.** Two pictures of building #5 (Punta Lena, Stromboli – Fig. 6) taken after the 2002 tsunami. The flow broke doors and windows, penetrated indoors and dragged the building contents outside **(a)**. A large crack can be observed in the front side wall **(b)**. However, that wall does not appear to be part of the load-bearing structure of the building, as does the undamaged column at its right. The PTVA-3 Model classified building #5 as having an “average” RVI score.

Figure 12 shows damage to building #5 (RVI = “average”). Like building #2 and 3, window and door frames have been ripped off the wall. The building interior has been completely destroyed and the contents widely dispersed. The im-

pact caused a crack in the front-wall, but left load-bearing column to its right undamaged (Fig. 12b). The front-porch has been almost completely destroyed. However, the load-bearing structure of the building is largely untouched.
